MONITORING COMPLETED COASTAL PROJECTS: OPERATIONAL ASSESSMENT OF FLOATING BREAKWATERS, PUGET SOUND, WASHINGTON

Eric E. Nelson

J. Michael Hemsley
Coastal Engineering Research Center

April 1988

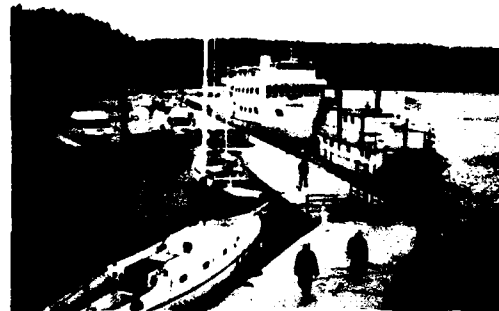
29. After project completion, the Port of Friday Harbor found that there was a considerable demand for moorage on the seaward side, particularly for large (75-ft) vessels (Photo 10). The Port requested that the Corps evaluate a proposal to moor large vessels on the seaward side of the breakwater. Additional loads that could be generated if large vessels were moored on the seaward side of the breakwater were calculated and found to be well within the allowable design criteria. However, safety concerns voiced by the Washington State Ferry System remain an unresolved issue. Finally, no adequate tie-up facilities are available on the seaward side of the breakwater, and if

permanent moorage for large vessels becomes possible, substantial mooring hardware improvements will have to be made because the breakwater receives extremely heavy use. In addition to mooring the capacity crowd of transient pleasure boats in the summer, it has proven to be a popular fishing pier for the local population.

Photo 10. Large vessels moored on seaward side of breakwater

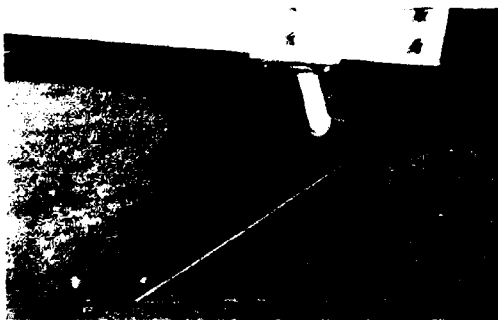
30. Lateral and longitudinal excursions of the breakwater were monitored by noting the extent of marks left on the breakwater by access ramp casters (Photo 11). Maximum longitudinal motion (north-south) was about ± 2.5 ft, and maximum lateral motion (east-west) was ± 6 in. North-south motion was probably increased by the sail effect of larger vessels temporarily moored to the B- and C-floats. Several minor storms from the south did not produce particularly large waves but did have winds in excess of 40 mph and may have been responsible for the maximum north-south excursions.

Photo 11. Caster marks indicating limits of motion

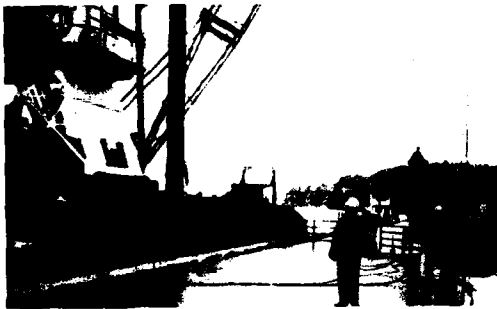
Photo 13. Breakwater anchor system being repaired by Corps' debris boat Puget

32. The repair involved releasing the seaward anchor line from the breakwater, lowering it under and around the landward anchor line, then reconnecting and retensioning it. Work was carried out with no difficulties, but the procedure did require the use of CENPS' debris boat Puget (105 ft long with a 20-ton capacity crane) and a four-man "hard-hat," or surface-supplied, air dive crew (Photo 13). Total cost for the repair was approximately \$10,000. Divers using surface-supplied air with communications linked to the surface were invaluable in adjusting final anchor line tensions to assure there was no contact between the anchor lines.

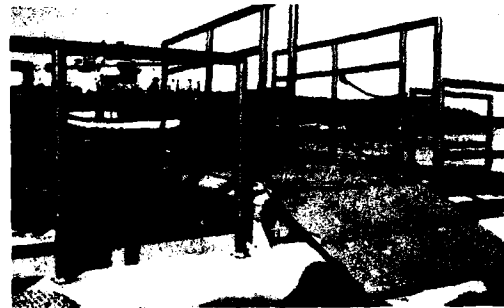
experienced several persistent maintenance problems. Access and interfloat ramps are only 4 ft wide (Photo 14). This width precludes access to the breakwater by electrically powered vehicles. The Port would like to use these vehicles to reduce travel time for the 1/2-mile round trip to the end of the breakwater. Stanchions, located on the breakwater to supply electrical service to transient boats, are relatively tall. Their height, combined with their placement near the edge of the breakwater, make them vulnerable to being knocked over by bowsprits of docking boats (Photo 15). This particular stanchion design is also prone to being pulled over by boaters who neglect to unplug their shore power lines before departing. Electrical junction boxes present another problem. The boxes are mounted flush with the deck, so they fill with water unless access plates are carefully sealed. Much of the hardware which provides mechanical support for the electrical wiring was not designed specifically for use in a marine environment; consequently this hardware is now badly corroded and eventually will have to be replaced.

Photo 14. Interfloat ramps

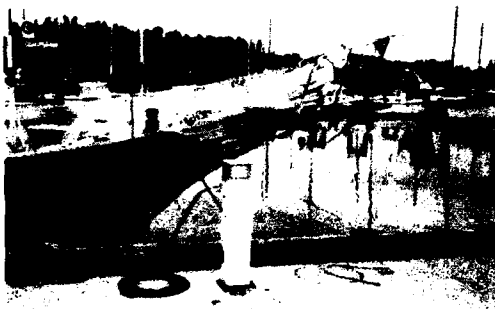
Photo 15. Electrical power post (junction box visible at base of post)

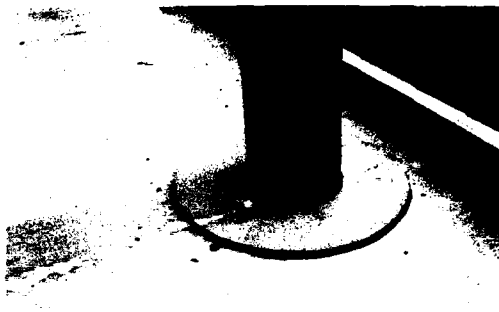
Photo 20. Temporary cover for the breakwater-piling gap
